## NEW MEXICO ENVIRONMENT DEPARTMENT

**Re: New Mexico State Police District 7 Headquarters; Construction General Permit (CGP);  
NMU001941; SIC 1592; August 9, 2017**

## NPDES Compliance Inspection Report

**New Mexico General Services Department**  
**Project: NEW MEXICO STATE POLICE, DISTRICT 7 HEADQUARTERS**  
**NPDES Compliance Evaluation Inspection**  
**NPDES Permit NMU001941**  
**Inspection Date: August 9, 2017**

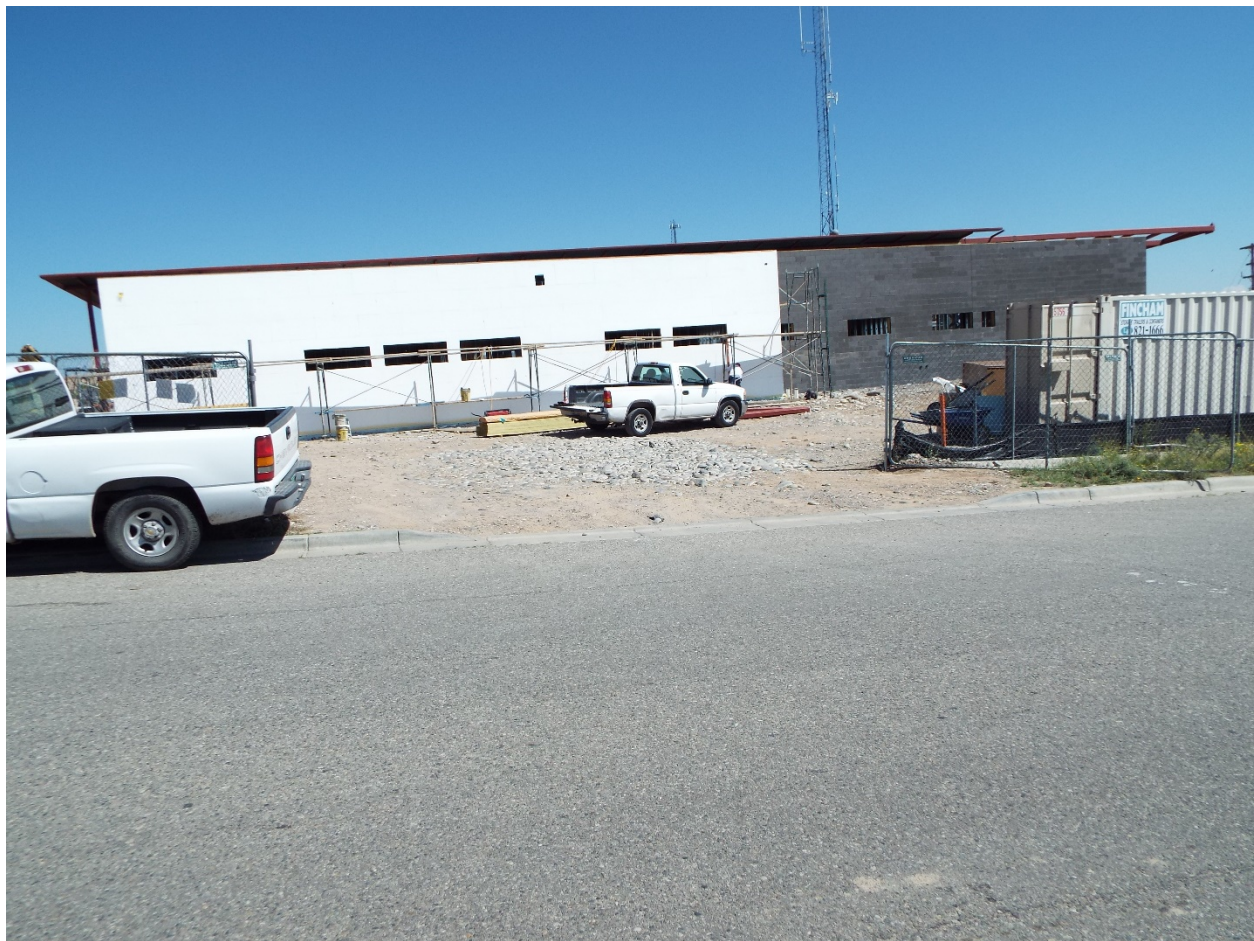
NMED/SWQB  
OFFICIAL PHOTO LOG  
PHOTO #1

Photographer: Daniel Valenta	Date: August 9, 2017	Time: 1046 Hours
City/County: Espanola/Rio Arriba		
Location: New Mexico State Police District 7 Headquarters		
Subject: One of two entrances on site. (southeast side)

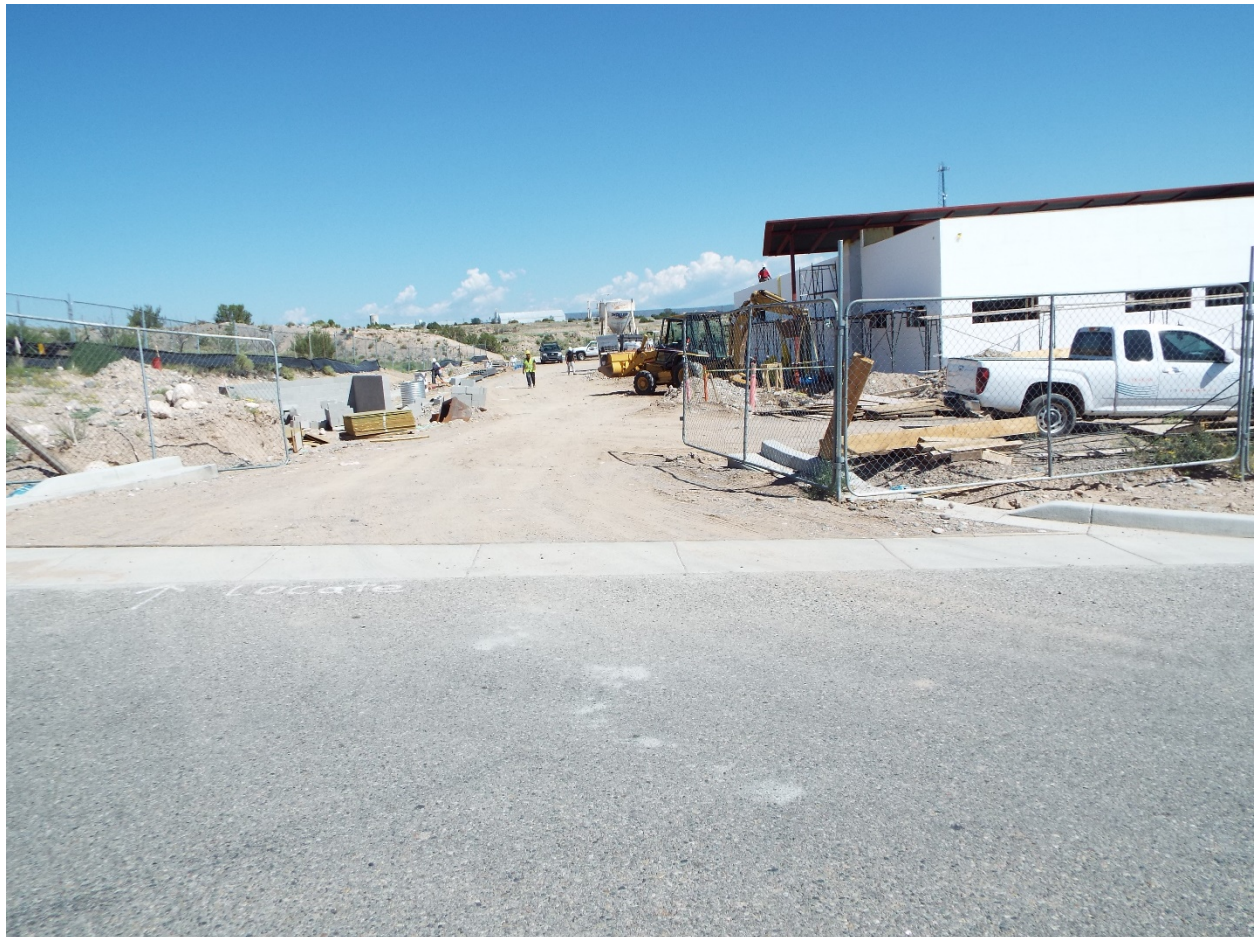
NMED/SWQB  
OFFICIAL PHOTO LOG  
PHOTO #2

Photographer: Daniel Valenta	Date: August 9, 2017	Time: 1046 Hours
City/County: Espanola/Rio Arriba		
Location: New Mexico State Police District 7 Headquarters		
Subject: One of two entrances on site. (southwest entrance) Part 2.2.4/Permit Requirements: Use appropriate stabilization techniques (e.g., use of aggregate stone with an underlying geotextile or non-woven filter fabric, and turf mats) at <b>all points that exit onto paved roads.</b>

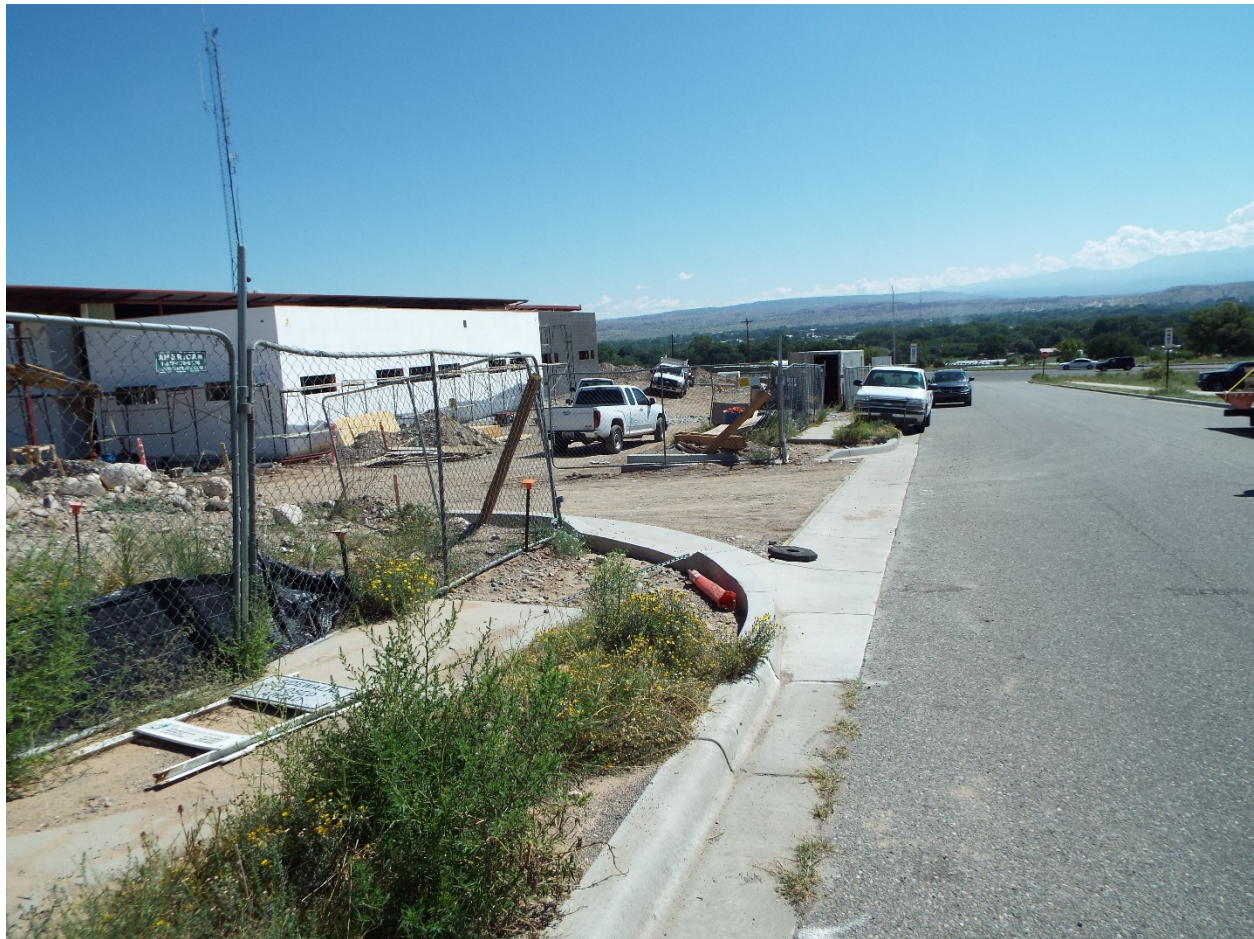
NMED/SWQB  
OFFICIAL PHOTO LOG  
PHOTO #3

Photographer: Daniel Valenta	Date: August 9, 2017	Time: 1046 Hours
City/County: Espanola/Rio Arriba		
Location: New Mexico State Police District 7 Headquarters		
Subject: One of two entrances on site. (southwest entrance) Part 2.2.4/Permit Requirements: Use appropriate stabilization techniques (e.g., use of aggregate stone with an underlying geotextile or non-woven filter fabric, and turf mats) at <b>all points that exit onto paved roads.</b>

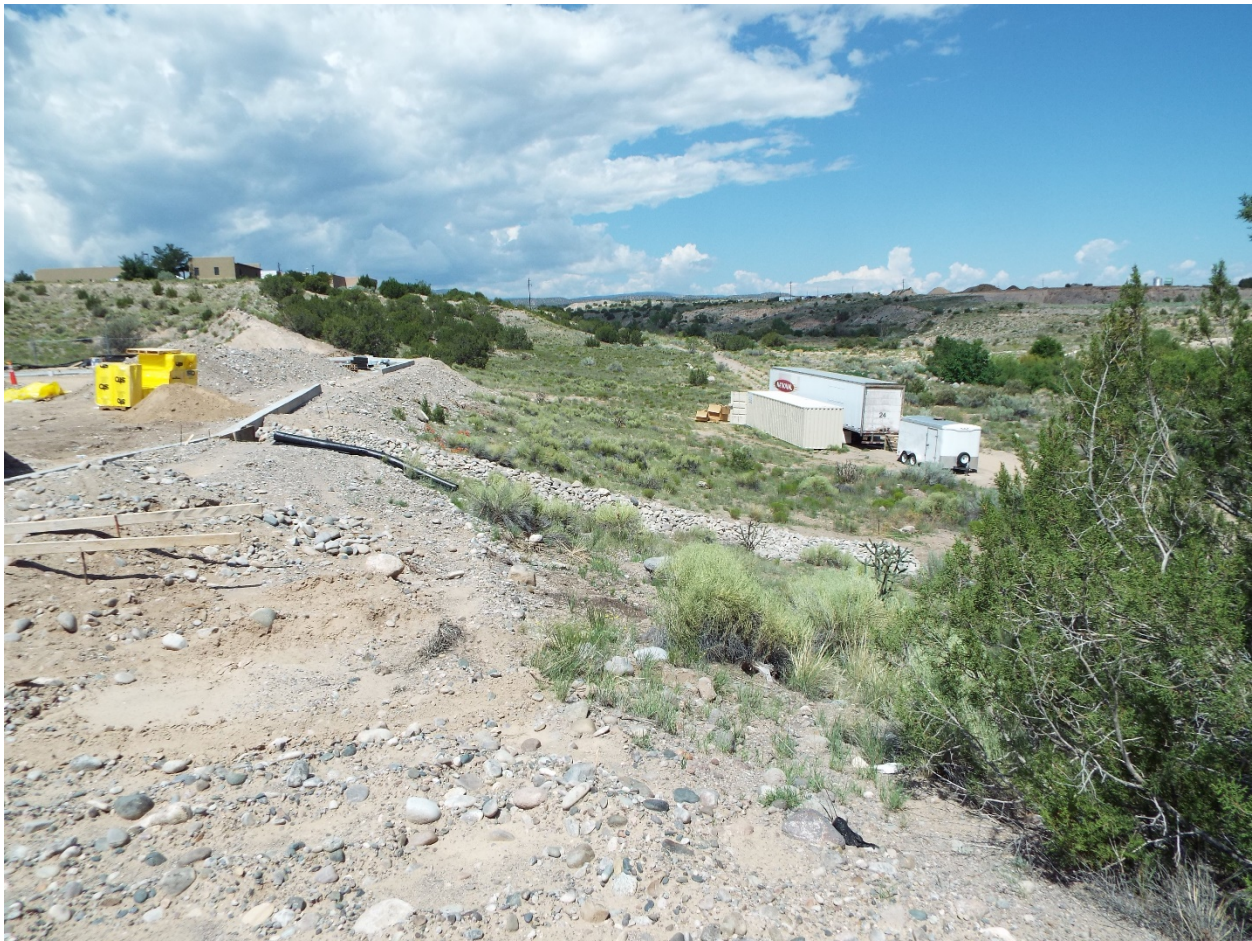
NMED/SWQB  
OFFICIAL PHOTO LOG  
PHOTO #5

Photographer: Daniel Valenta	Date: August 9, 2017	Time: 1046 Hours
City/County: Espanola/Rio Arriba		
Location: New Mexico State Police District 7 Headquarters		
Subject: North side of property looking west. Created spillway with curbing in place.

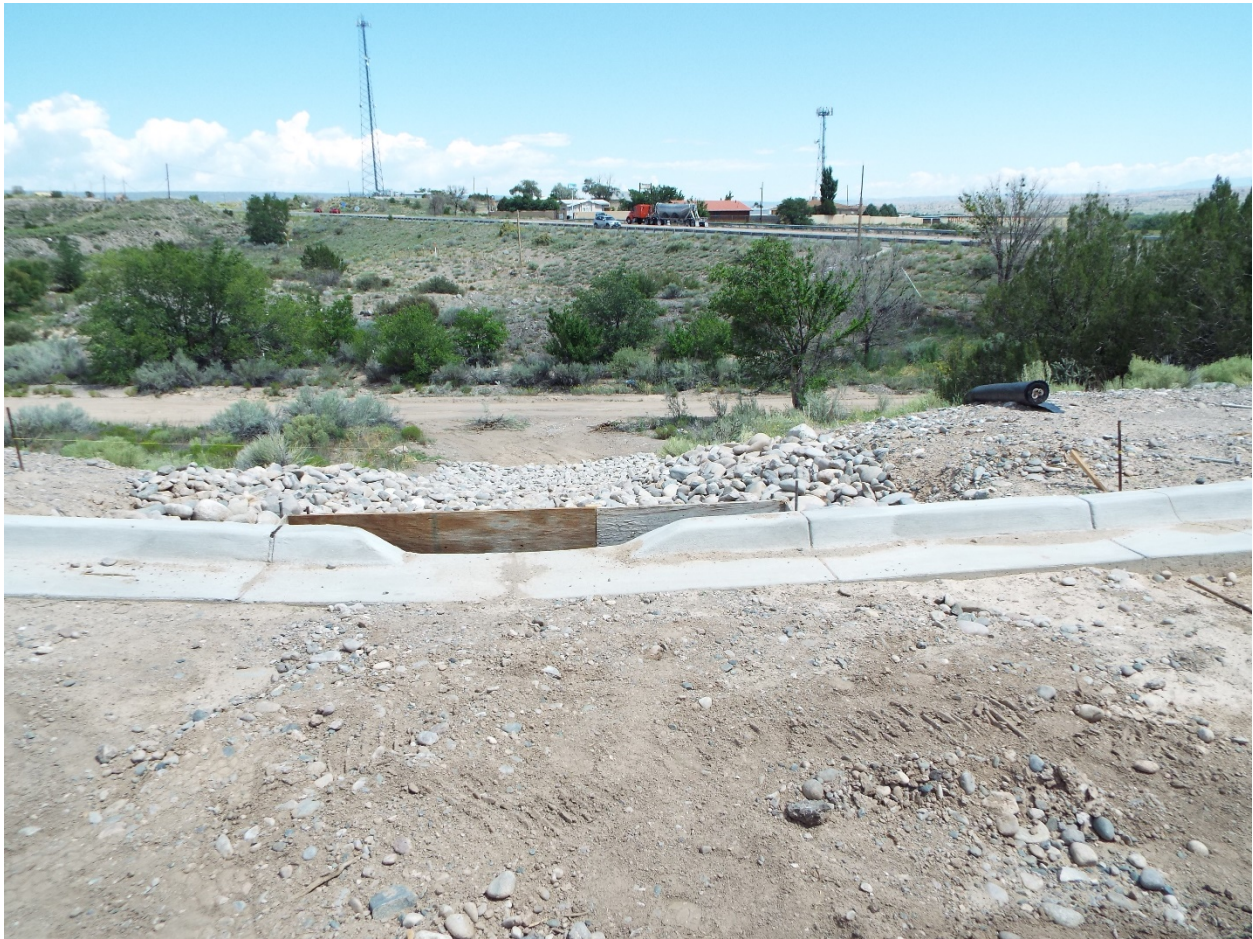
NMED/SWQB  
OFFICIAL PHOTO LOG  
PHOTO #6

Photographer: Daniel Valenta	Date: August 9, 2017	Time: 1138 Hours
City/County: Espanola/Rio Arriba		
Location: New Mexico State Police District 7 Headquarters		
Subject: North side of property looking north. Created spillway with curbing cutout for drainage purposes.

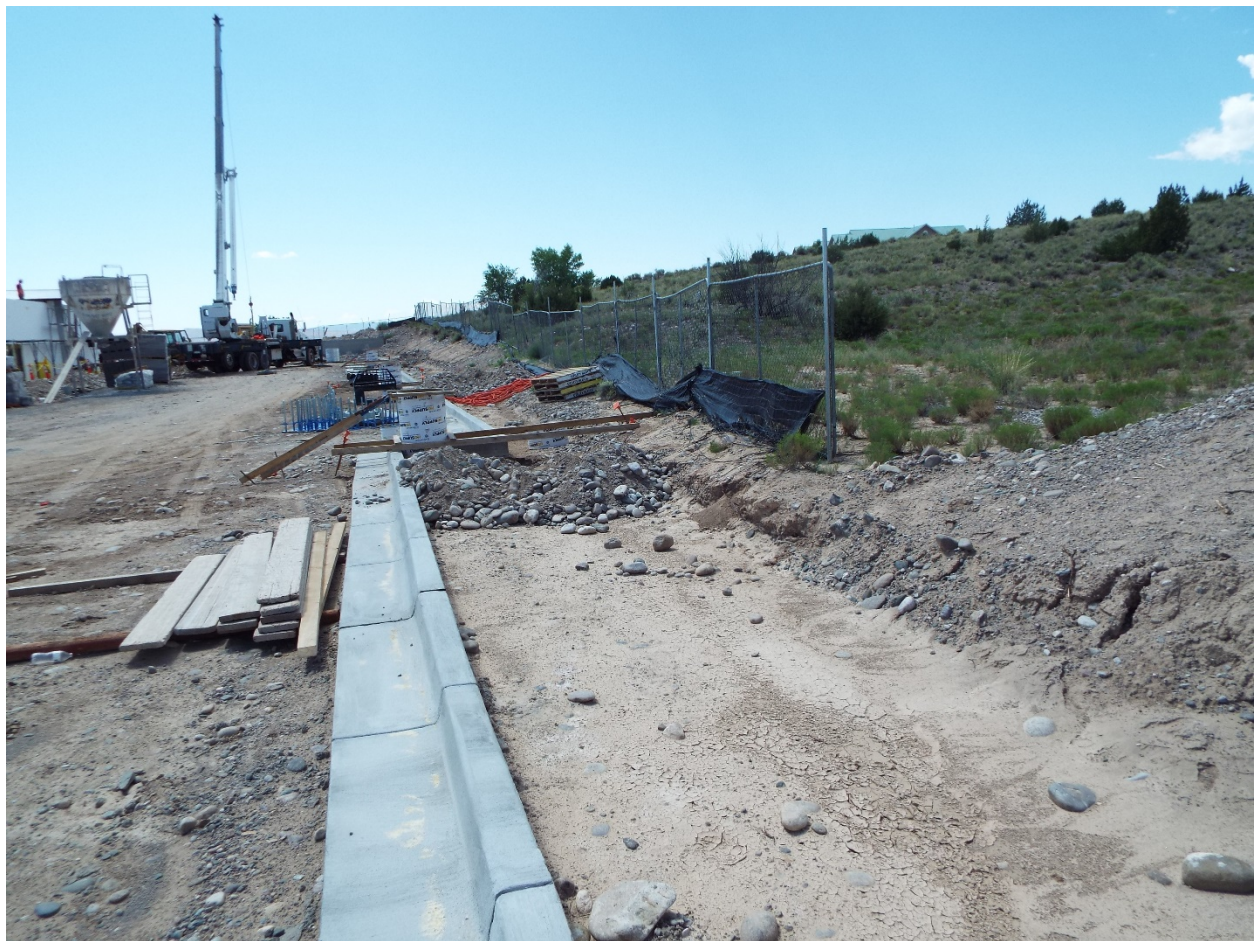
NMED/SWQB  
OFFICIAL PHOTO LOG  
PHOTO #7

Photographer: Daniel Valenta	Date: August 9, 2017	Time: 1140 Hours
City/County: Espanola/Rio Arriba		
Location: New Mexico State Police District 7 Headquarters		
Subject: West side of property.

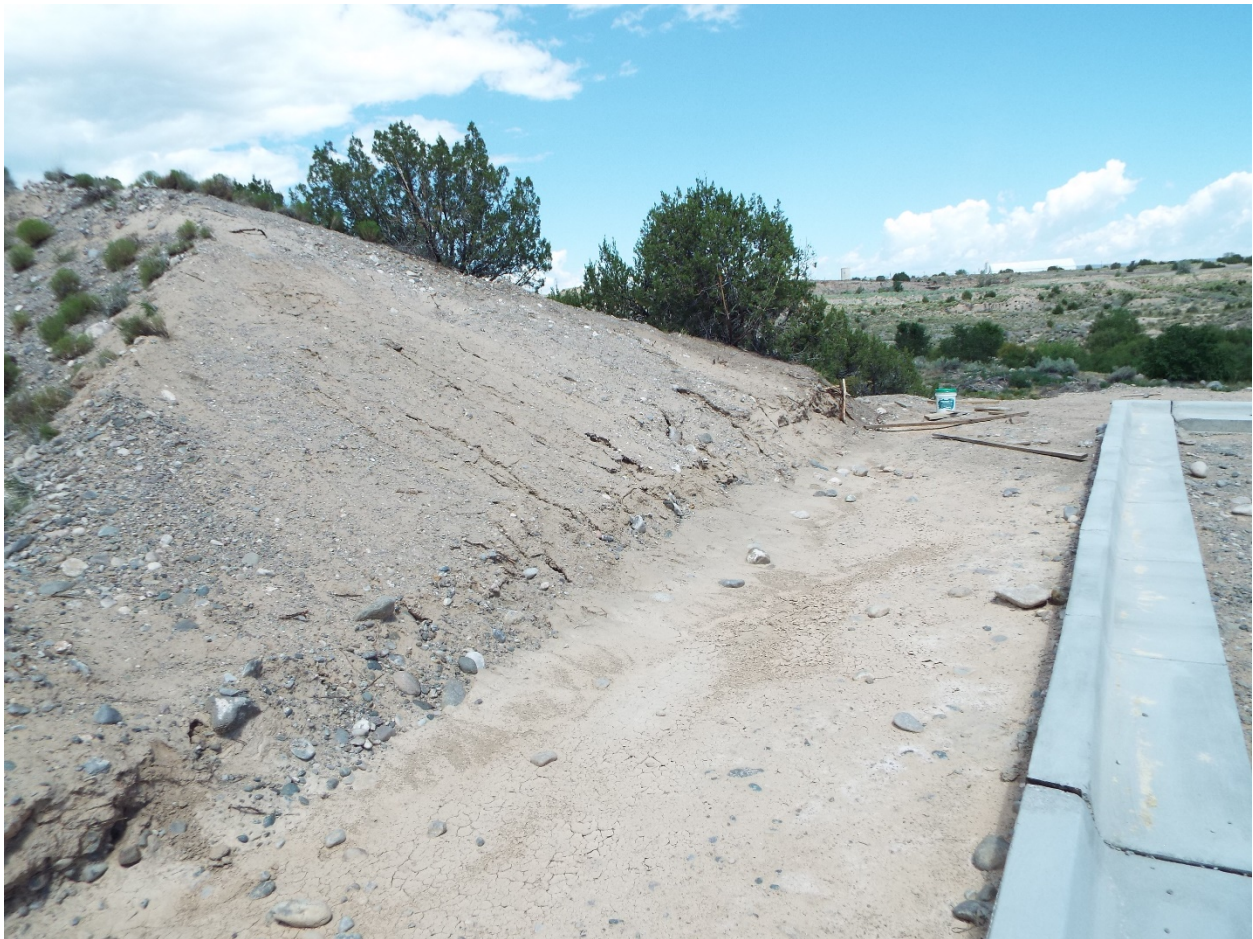
NMED/SWQB  
OFFICIAL PHOTO LOG  
PHOTO #7

Photographer: Daniel Valenta	Date: August 9, 2017	Time: 1140 Hours
City/County: Espanola/Rio Arriba		
Location: New Mexico State Police District 7 Headquarters		
Subject: West side of property

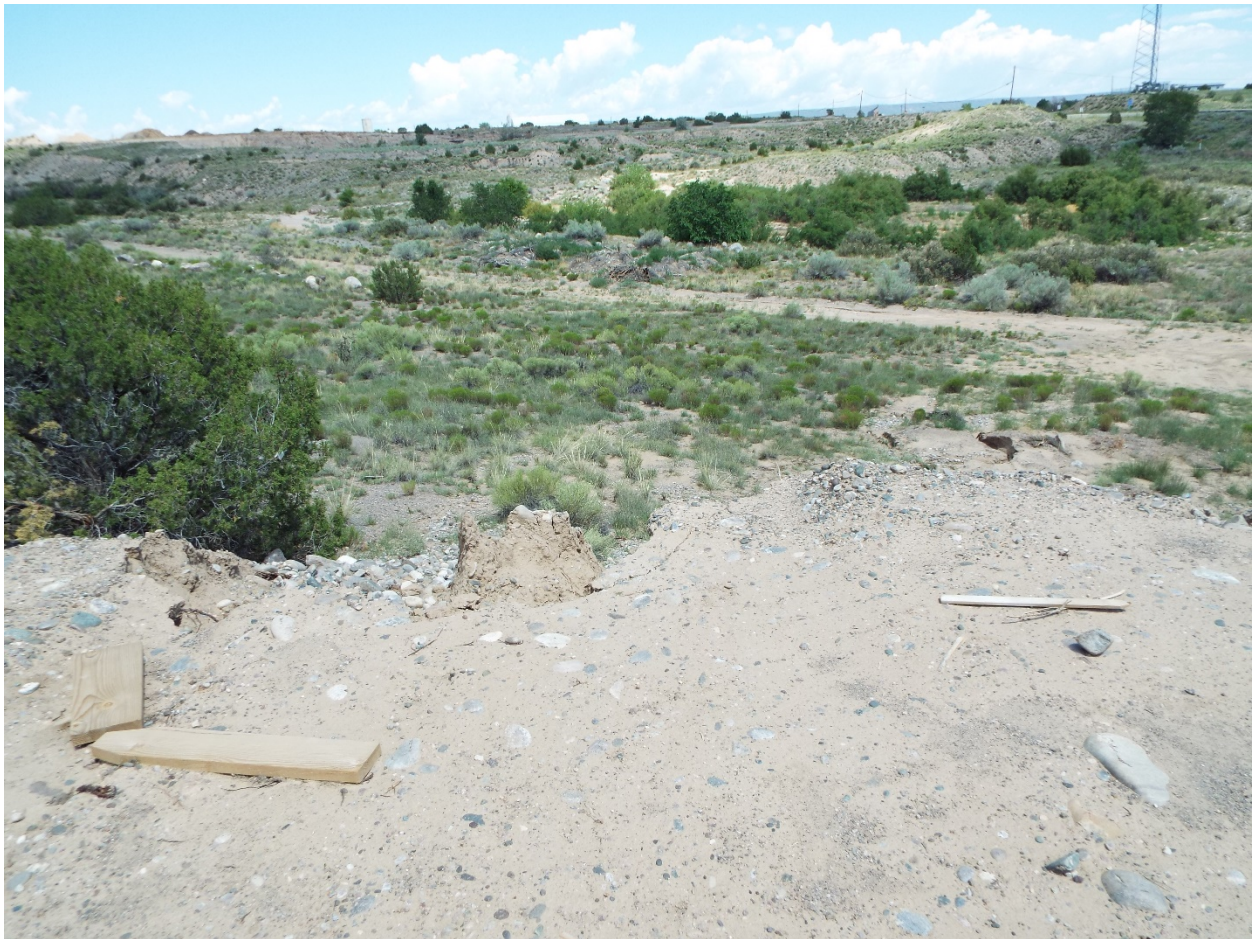
NMED/SWQB  
OFFICIAL PHOTO LOG  
PHOTO #8

Photographer: Daniel Valenta	Date: August 9, 2017	Time: 1141 Hours
City/County: Espanola/Rio Arriba		
Location: New Mexico State Police District 7 Headquarters		
Subject: West side of property

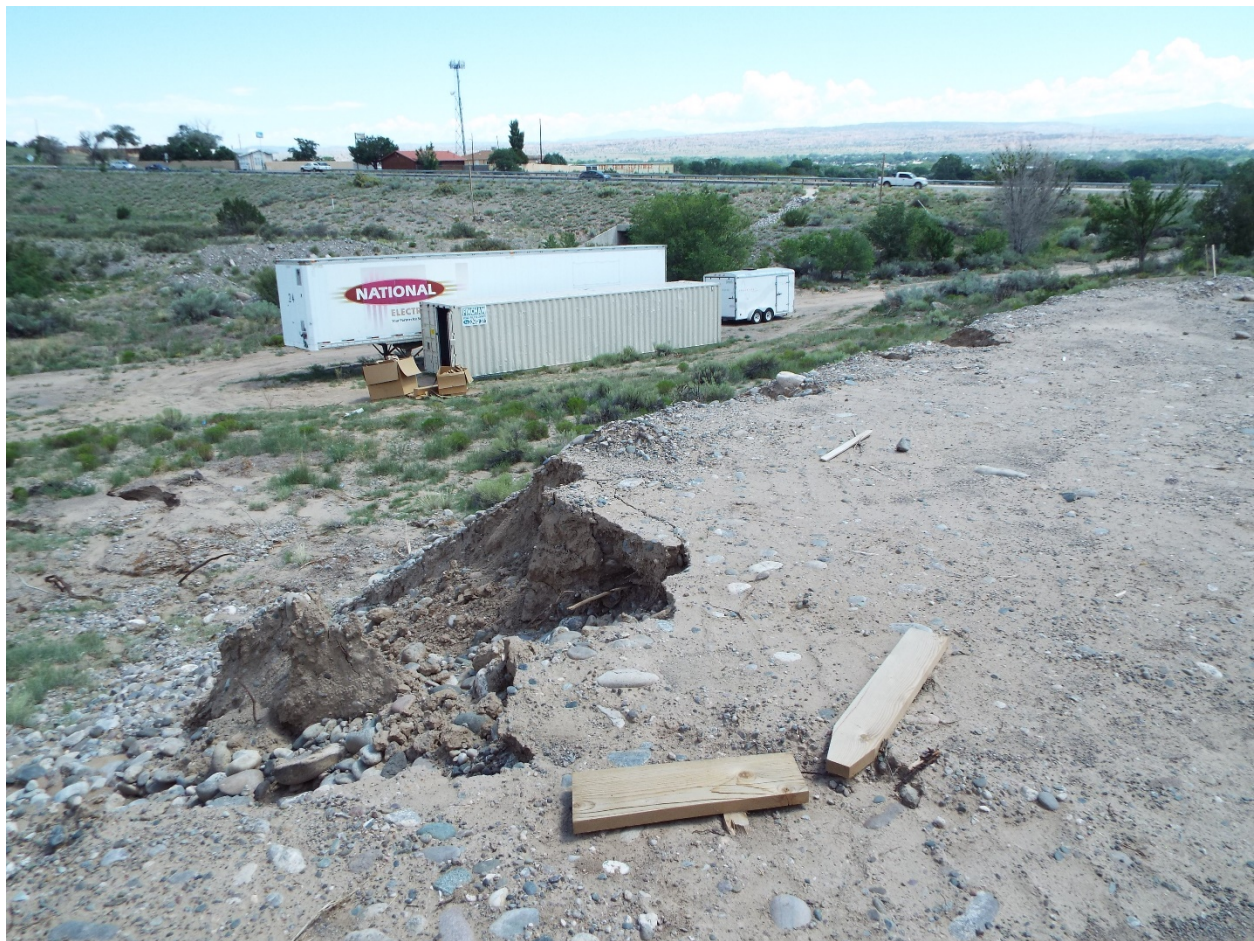
NMED/SWQB  
OFFICIAL PHOTO LOG  
PHOTO #8

Photographer: Daniel Valenta	Date: August 9, 2017	Time: 1141 Hours
City/County: Espanola/Rio Arriba		
Location: New Mexico State Police District 7 Headquarters		
Subject: West side of property

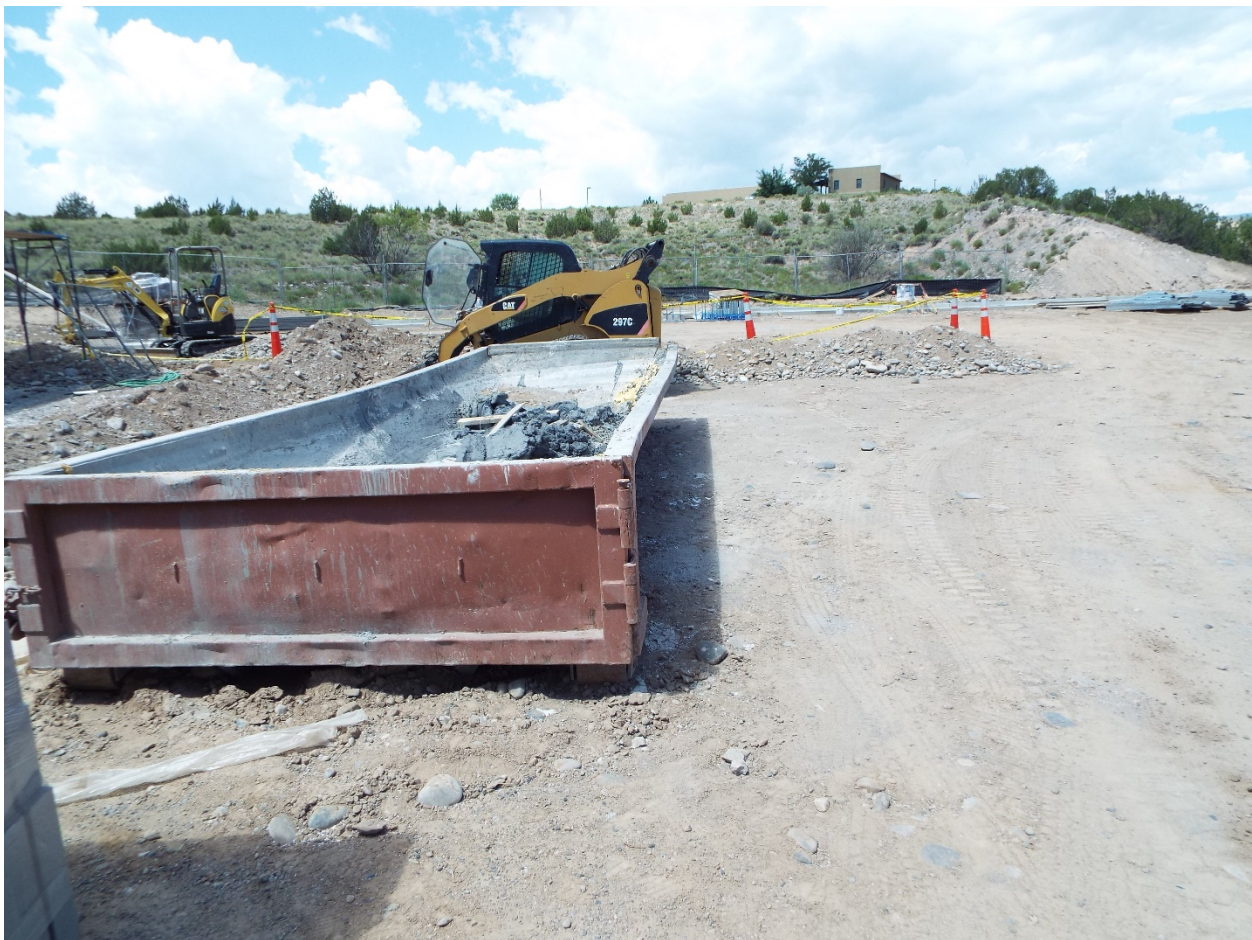
NMED/SWQB  
OFFICIAL PHOTO LOG  
PHOTO #9

Photographer: Daniel Valenta	Date: August 9, 2017	Time: 1138 Hours
City/County: Espanola/Rio Arriba		
Location: New Mexico State Police District 7 Headquarters		
Subject: Concrete washout container.

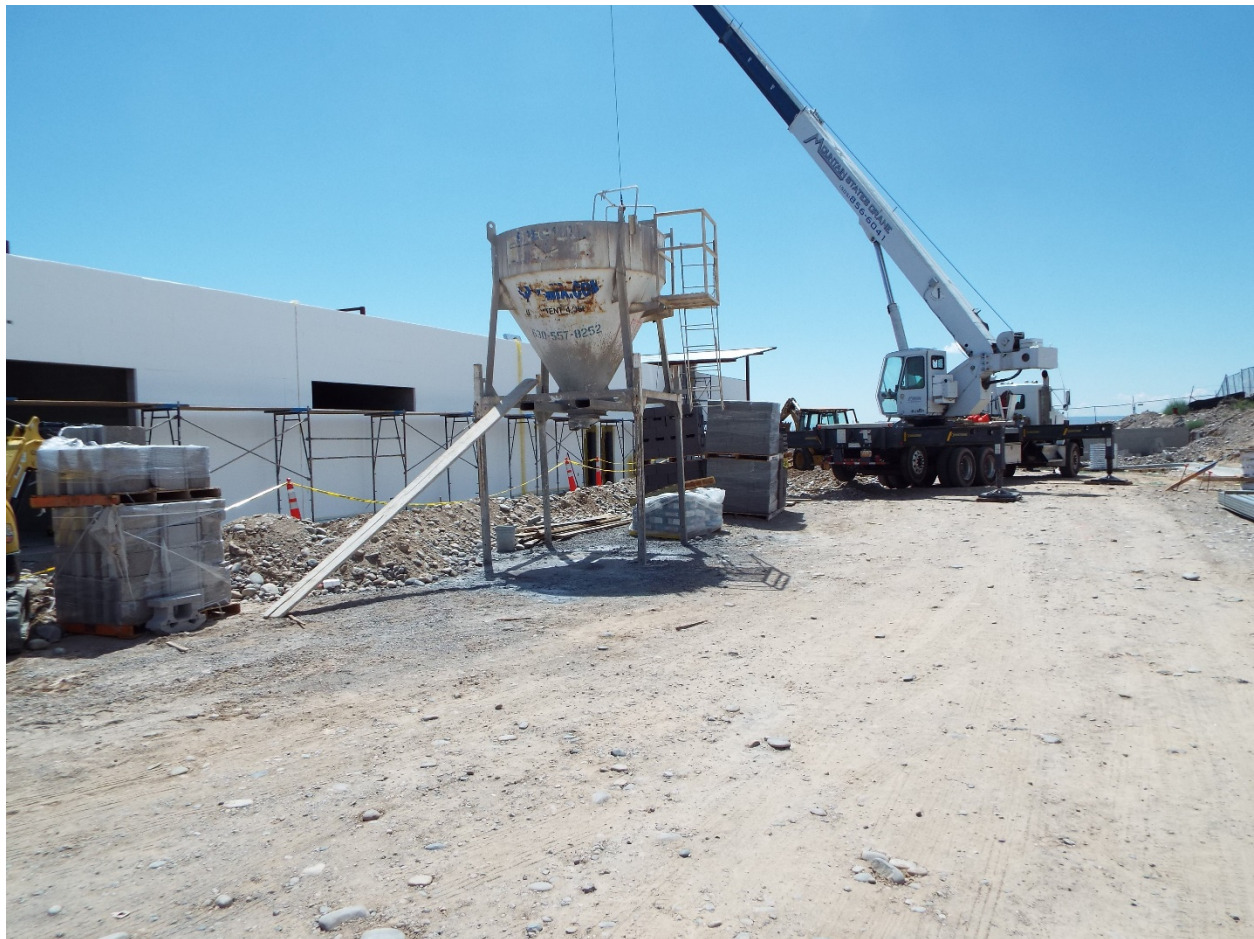
NMED/SWQB  
OFFICIAL PHOTO LOG  
PHOTO #10

Photographer: Daniel Valenta	Date: August 9, 2017	Time: 1143 Hours
City/County: Espanola/Rio Arriba		
Location: New Mexico State Police District 7 Headquarters		
Subject: Temporary Cement Plant west side of property / Part 2.3.4: Applicator and Container Washing Requirements: Direct washwater into a leak-proof container or leak-proof and lined pit designed so that no overflows can occur due to inadequate sizing.

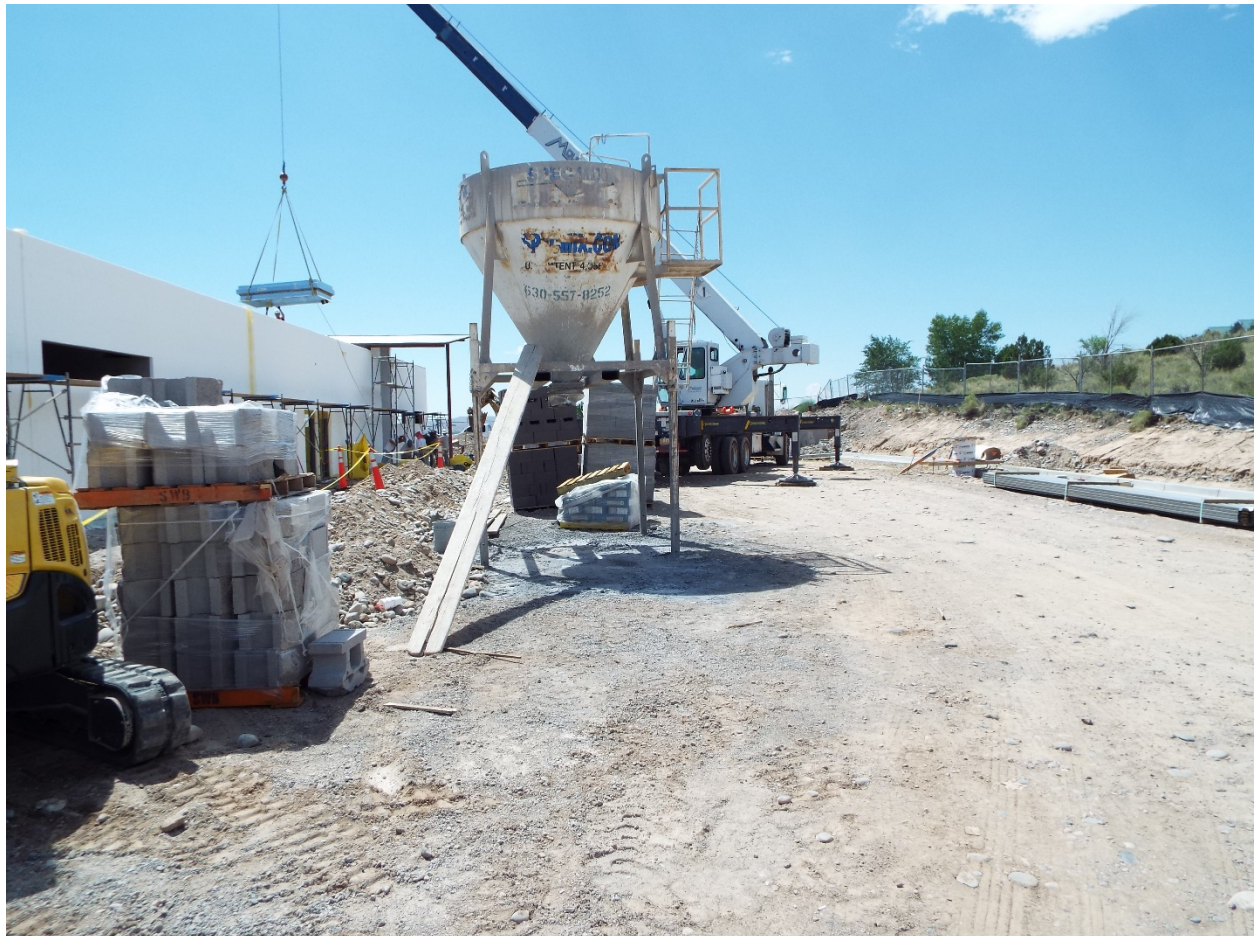
NMED/SWQB  
OFFICIAL PHOTO LOG  
PHOTO #11

Photographer: Daniel Valenta	Date: August 9, 2017	Time: 1143 Hours
City/County: Espanola/Rio Arriba		
Location: New Mexico State Police District 7 Headquarters		
Subject: Temporary Cement Plant west side of property / Part 2.3.4: Applicator and Container Washing Requirements: Direct washwater into a leak-proof container or leak-proof and lined pit designed so that no overflows can occur due to inadequate sizing.

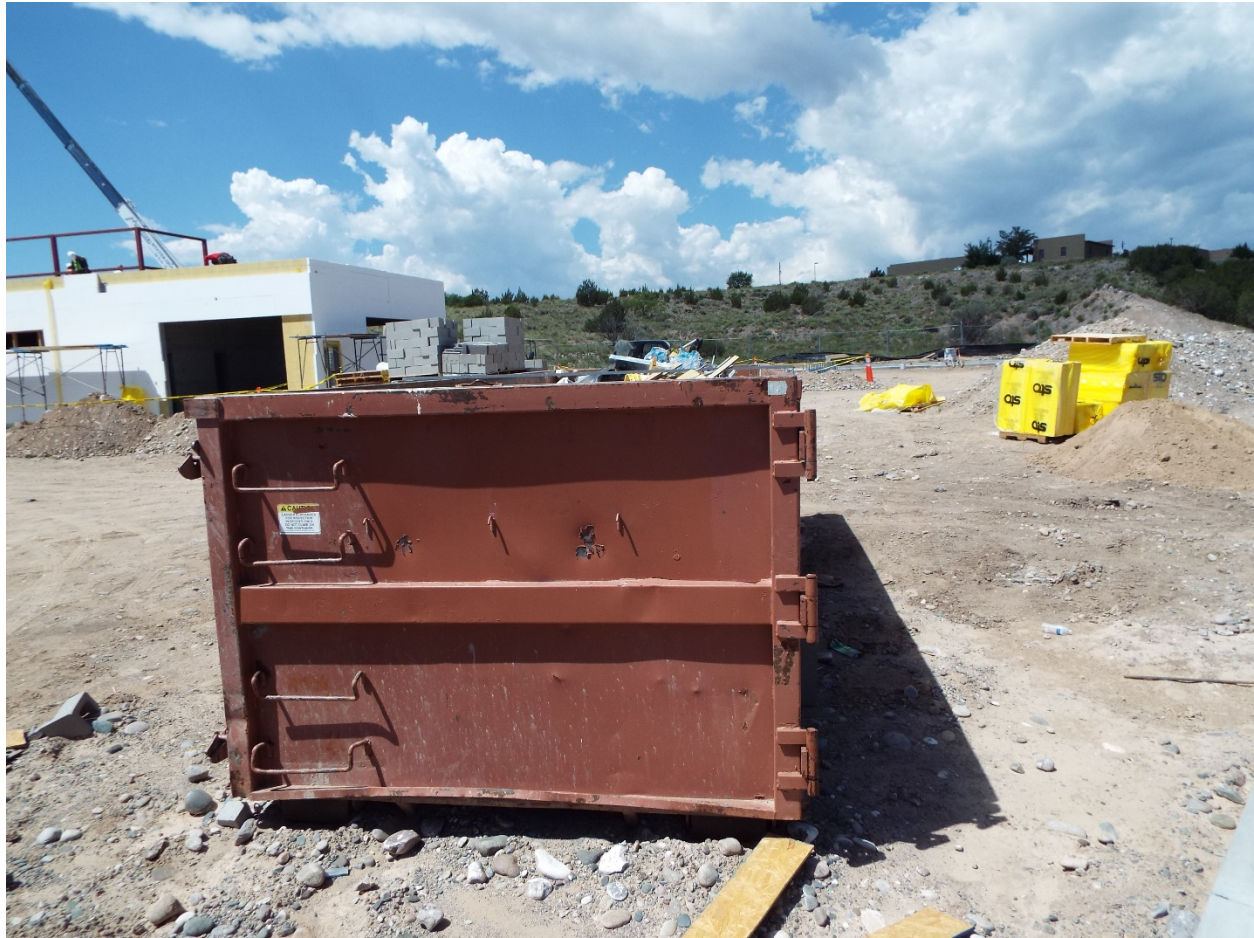
NMED/SWQB  
OFFICIAL PHOTO LOG  
PHOTO #12

Photographer: Daniel Valenta	Date: August 9, 2017	Time: 1137 Hours
City/County: Espanola/Rio Arriba		
Location: New Mexico State Police District 7 Headquarters		
Subject: Construction/Domestic trash dumpster / Part 2.3.3.e Requirements: For construction and domestic waste: Provide waste containers (e.g., dumpster, trash receptacle) of sufficient size and number. Keep waste container <b>lids closed</b> when not in use and close lids <b>at the end of the business day</b> for those containers that are actively used throughout the day.
